# SEALKOTE ON DETERIORATED ASPHALT SURFACE

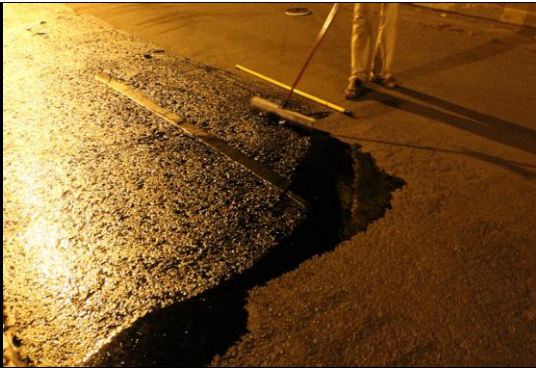
SEALKOTE application on most deteriorated surface at the rate of 1 Kg per SqMt done on 3<sup>rd</sup> May 2012

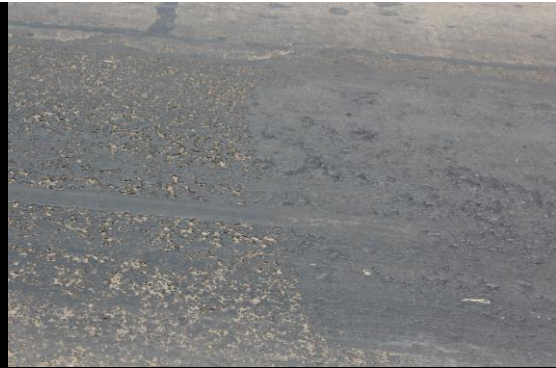
As can be seen the uncoated surface on the left has almost lost all binding of asphalt

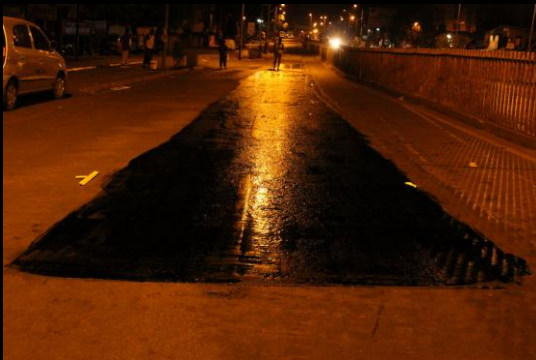
Application of SEALKOTE done on 150 SqMts of deteriorated surface having maximum traffic movement and maximum wear and tear

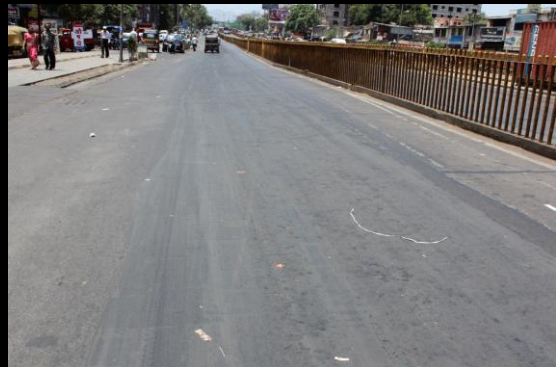
Next day of SEALKOTE application, visible surface undulations where asphalt has degraded on the right half of the asphalt road next to the concrete part

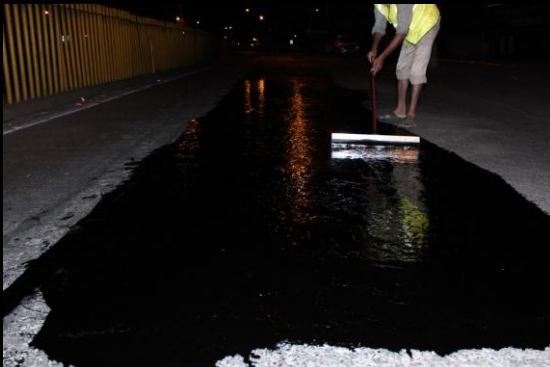
SEALKOTE application with squeeze, visible undulation of the rough surface like alligator back, final stages of wear

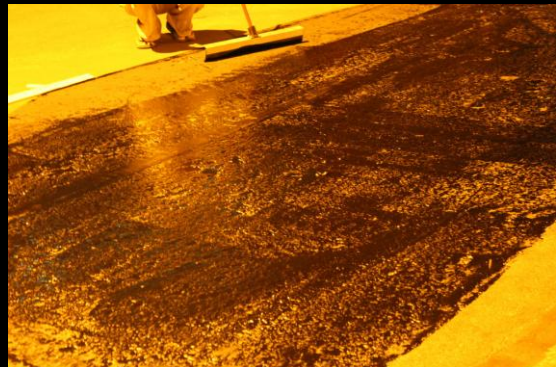
SEALKOTE application complete most of the coating has been absorbed by the porous and worn out surface

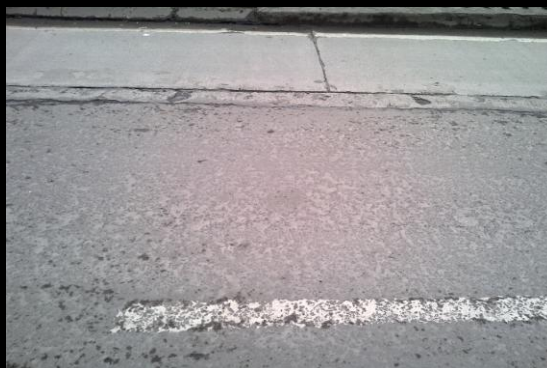
Surface as on 1<sup>st</sup> August 2014, same condition as on the date of application after two seasonal rains no further damage, the gravel is still intact and SEALKOTE has held it together
