## SEALKOTE PATCH REPAIR IN HEAVY MONSOON

These potholes were repaired at Tadi Gutta Chowk, Mundhwa road and north main road, from Koregaon Park, junction on 25<sup>th</sup> July 2013

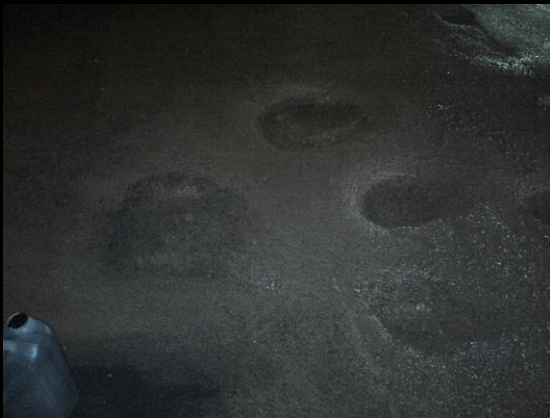
Potholes filled with water sized and shaped at the edges

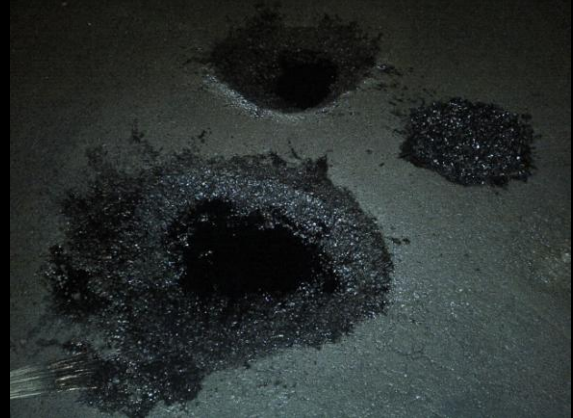
SEALKOTE PATCH applied as tack coat, visible penetration even in dirt filled pothole

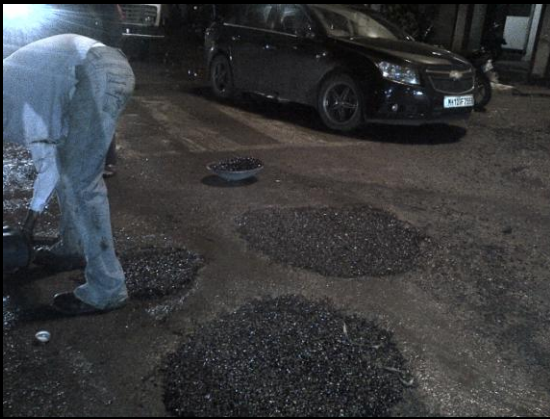
Next potholes filled with DBM (hot mix) into the SEALKOTE PATCH primed potholes

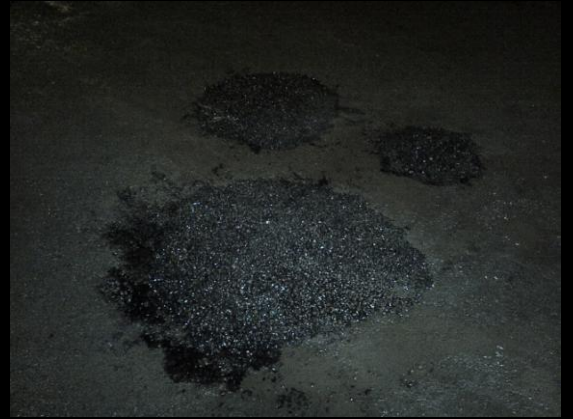
Fill pothole with an excess of DBM and have it suitably crowned and ready for compaction

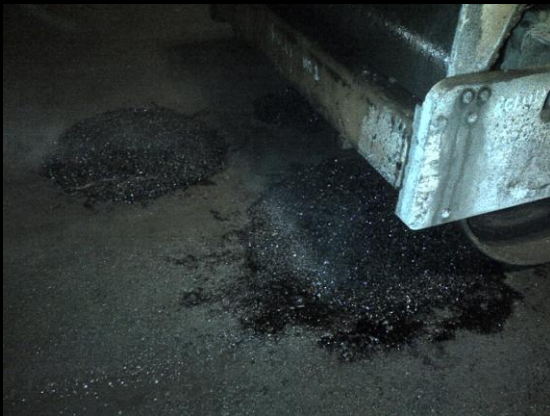
The repaired patch is compacted with a road roller and open to traffic immediately

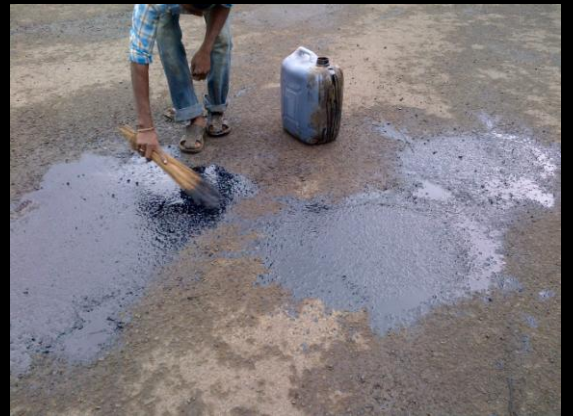
Apply SEALKOTE SB on the next day, but if the rains are heavy apply SEALKOTE SB immediately after compaction and open for traffic in 10 mins
